ASBESTOS INVESTIGATION REPORT

**Former China Delight
1632 Hwy 25B
Heber Springs, Arkansas 72543**

PROJECT NO. 21-0111-082

June 14, 2021

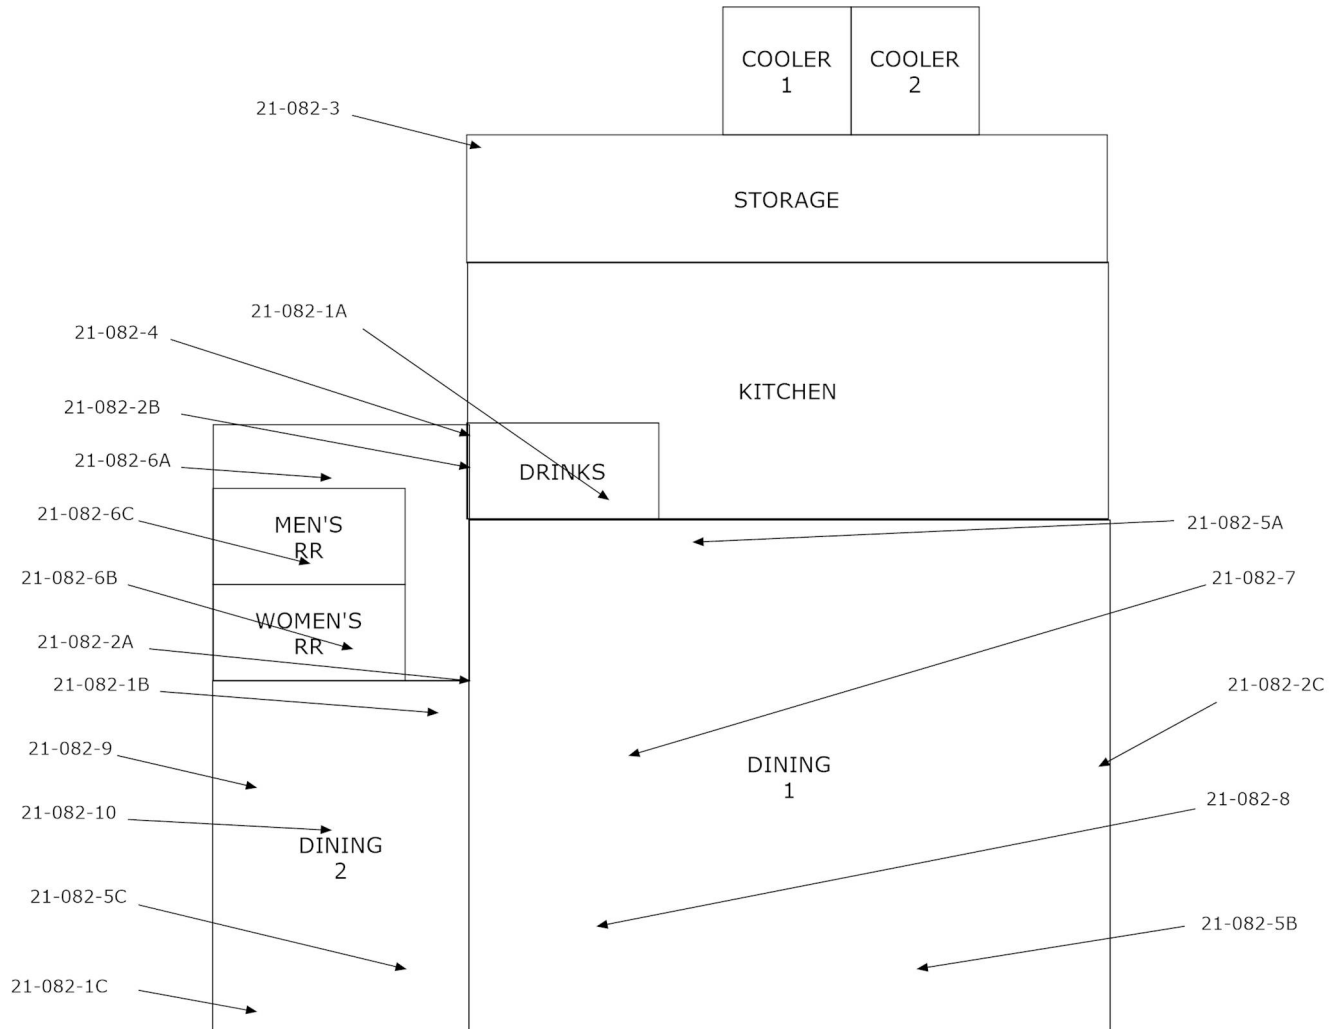
SAMPLE LOCATIONS

MATERIAL	SAMPLE LOCATION
Vinyl Plank Flooring & Mastic	Dining Room 2 & Drinks Area
Covebase & Mastic	Restroom Hallway & Dining Room 1
Drywall System	Storage (1980 Portion)
Drywall System	Restroom Hallway (1998 Portion)
White 2' x 2' Ceiling Tile	Dining Room 1 & Dining Room 2
White 2' x 4' Ceiling Tile	Restroom Hallway, Women's Restroom & Men's Restroom
Built-Up Roof	Roof (1980 Portion)
Roof Penetration Mastic	Roof (1980 Portion)
White Roof Coating	Roof (1998 Portion)
Roof Penetration Mastic	Roof (1998 Portion)
